Residential Date of inspection: Friday, 08 May 2020 11:30 AM

Pre-purchase Inspection Report

1 Hex Street

WEST FOOTSCRAY VIC 3012

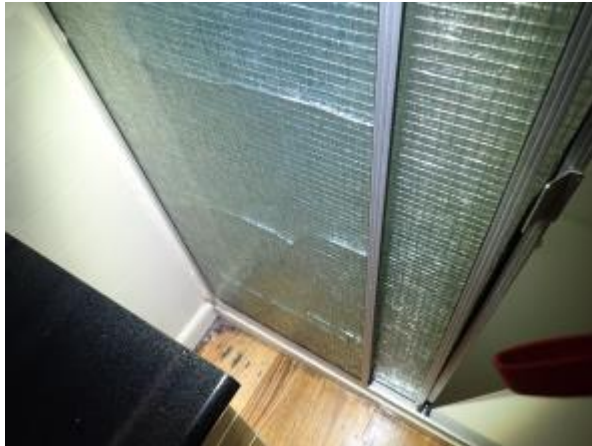
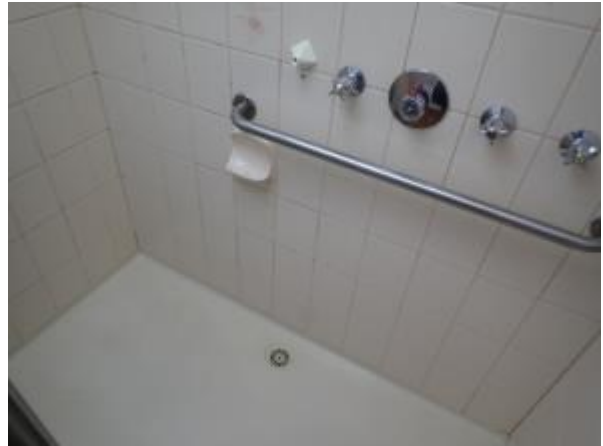
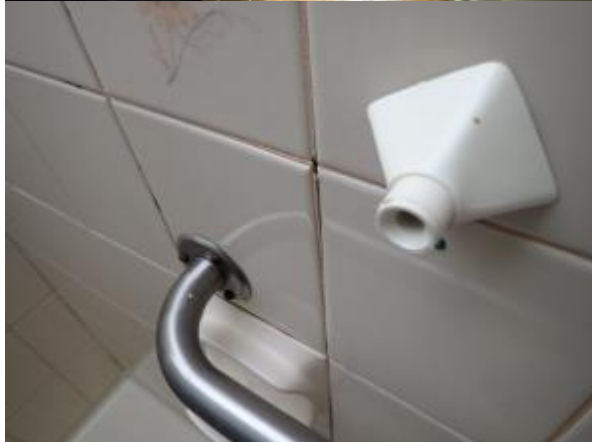
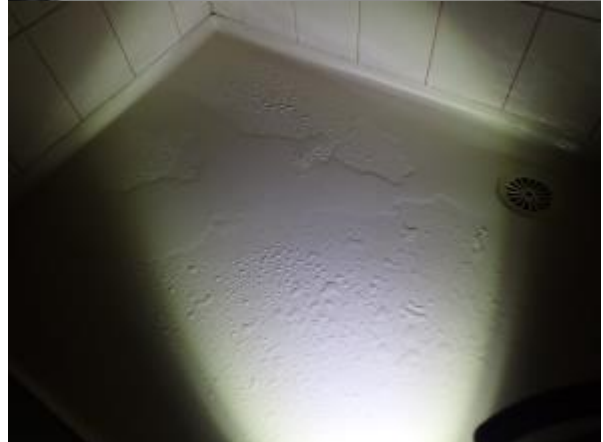
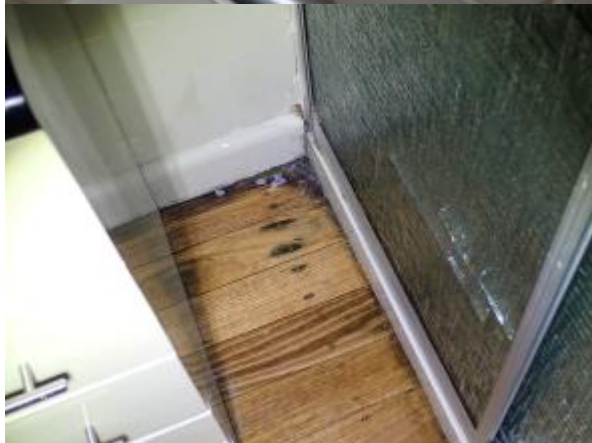
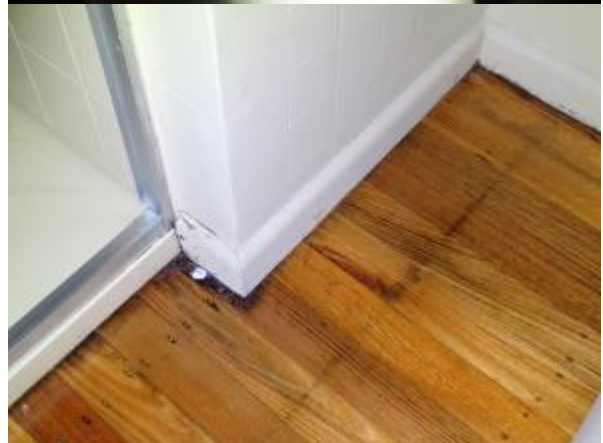
Various defects

Poor condition

Major Defect

1. Cracked shower screen
2. Drummy shower tiles - it is recommended a wall and sub-floor cavity is undertaken to determine extent of any rot to these structures prior to making the purchasing decision.
3. The shower base does not fall water completely toward the waste point due to movement of the sub-floor structure.
4. Water staining to the flooring at the shower base junction - water flow may have caused rot to the sub-floor structure.

A complete gut out and renovation of the bathroom is highly recommended. Costings should be sought prior to making the purchasing decision. The most significant defects recorded below;

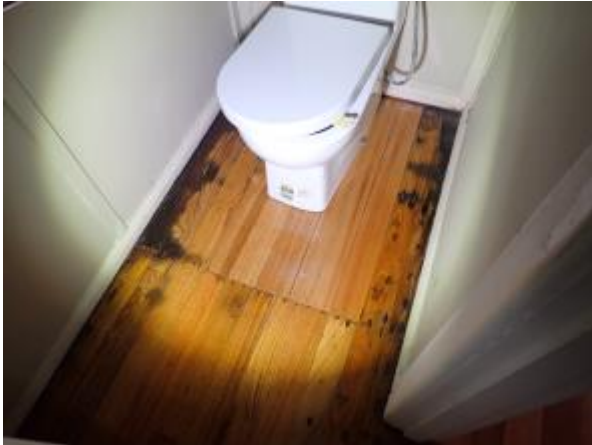
Floors

Water staining

Further Investigation Type: D

An invasive inspection of the sub-floor void is required to determine sub-floor condition.

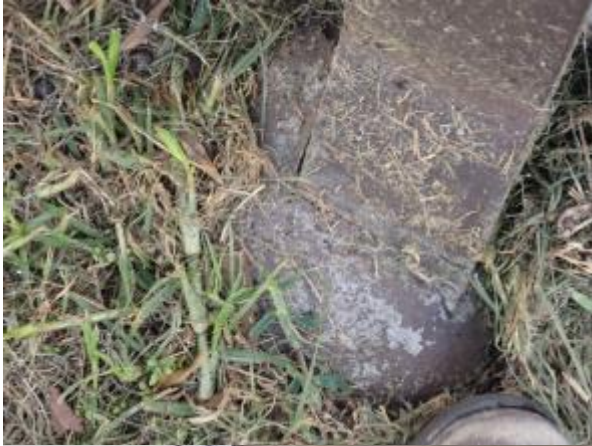
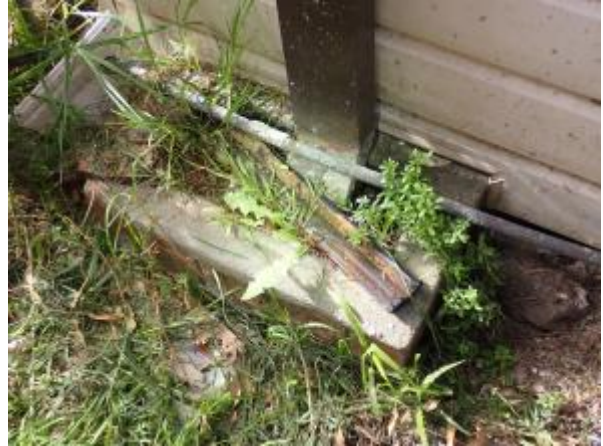
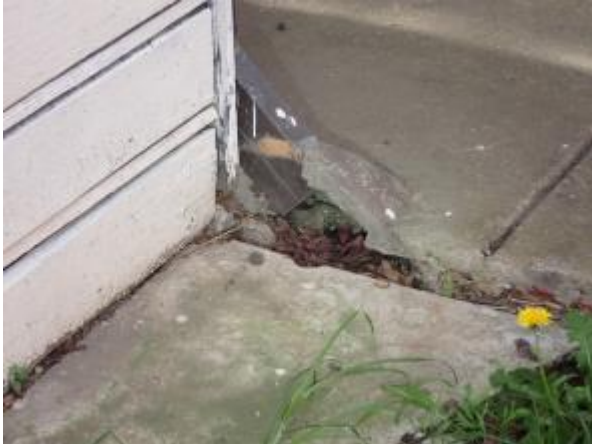
Plumbing Original earthen ware storm water Further Investigation Type: F
 system in place

ACCTV camera inspection is required to determine condition of the underground storm water pipes. Sewer pipes should also be investigated. Considering the age and materials of the system, replacement is highly recommended.

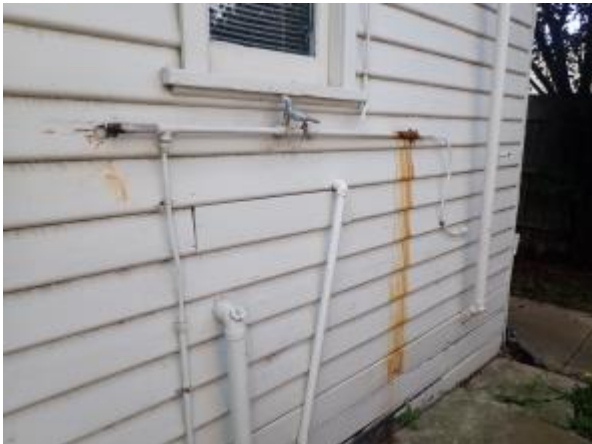
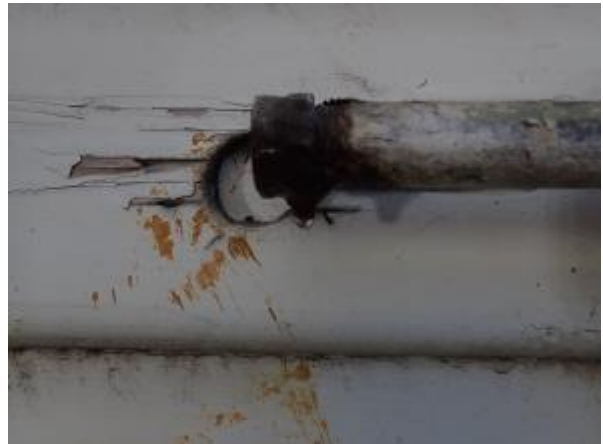
Plumbing Corroded and leaking water supply Further Investigation Type: D
 pipes

Further investigation of all water supply pipes is required by a qualified plumber. It is highly recommended that all steel pipes are replaced from the council asset through the home.

Gas service should also be inspected prior to making the purchasing decision.

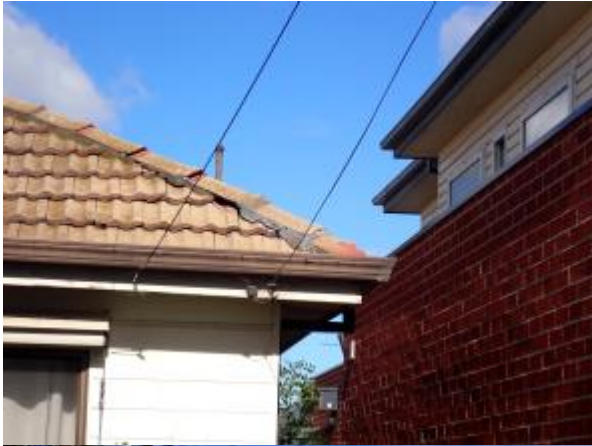
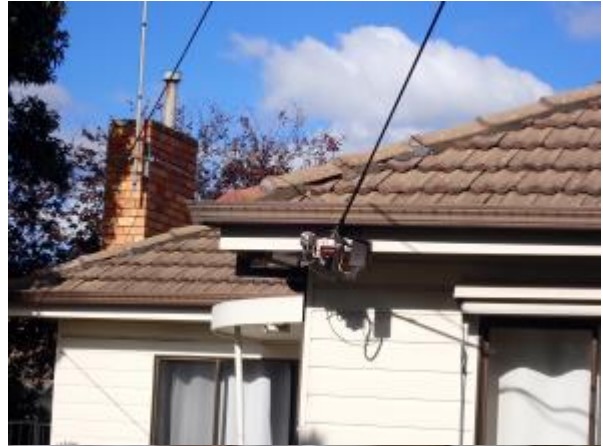
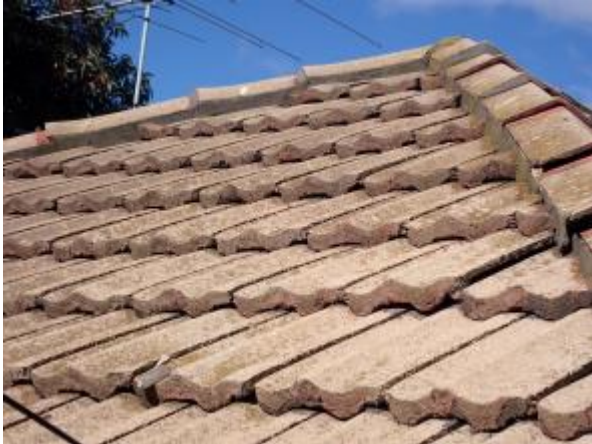
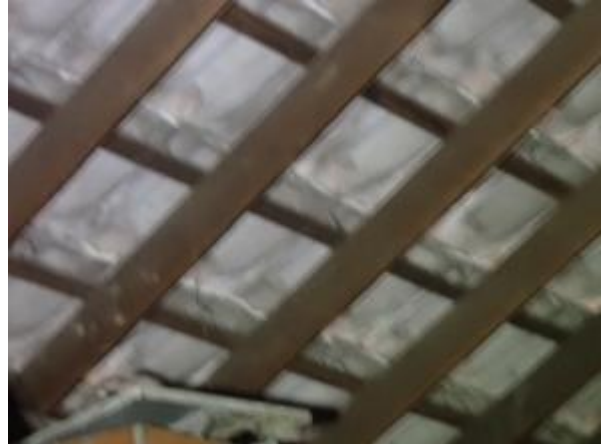
Roof tiles

Minor Defect

Type: D

Replacement roof tiles required.

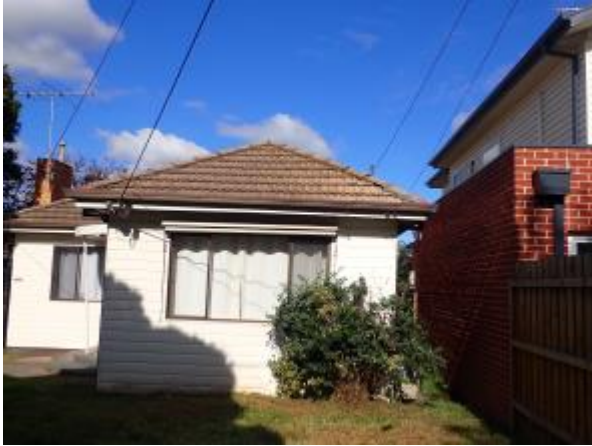
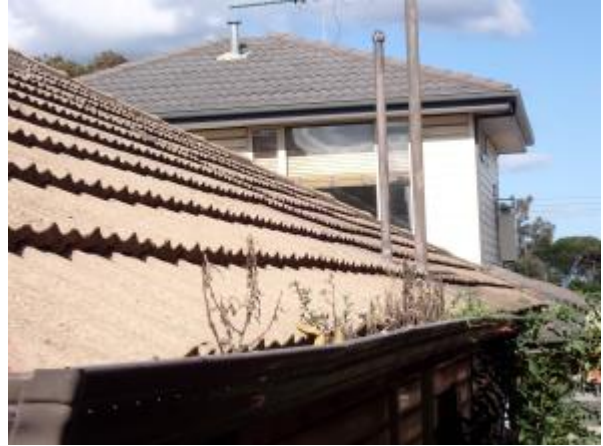
Roof framing

Major Defect

Type: A

Caused due to significant movement of the sub-floor structure. A qualified carpenter experienced in construction conventional roof structures required to rectify once poor site drainage, storm water system is replaced and rectification of the sub-floor structure is undertaken. Costs should be sought prior to making the purchasing decision.

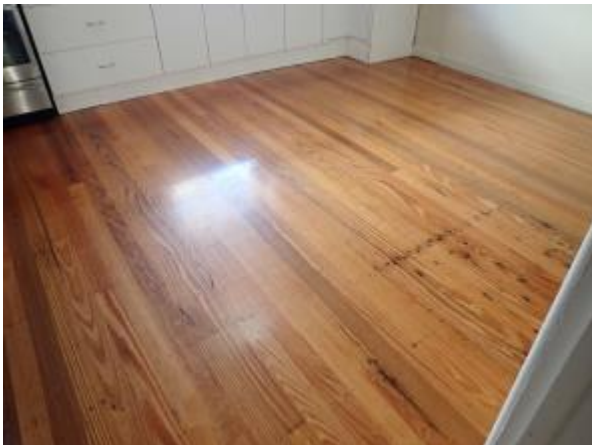
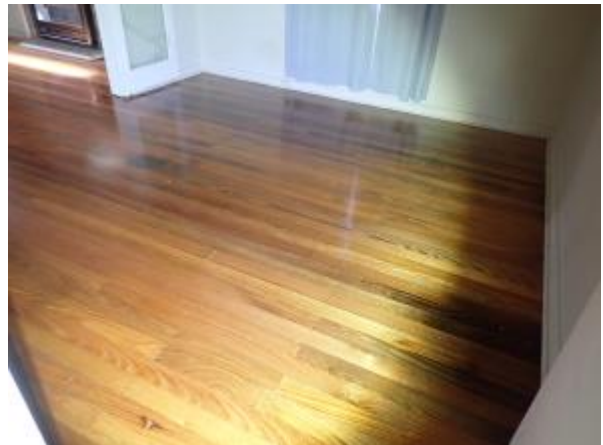
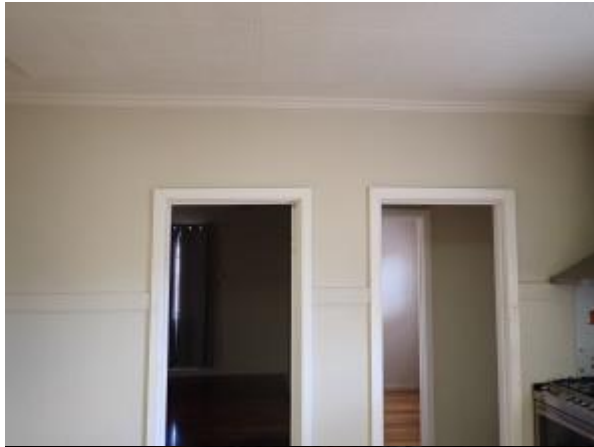
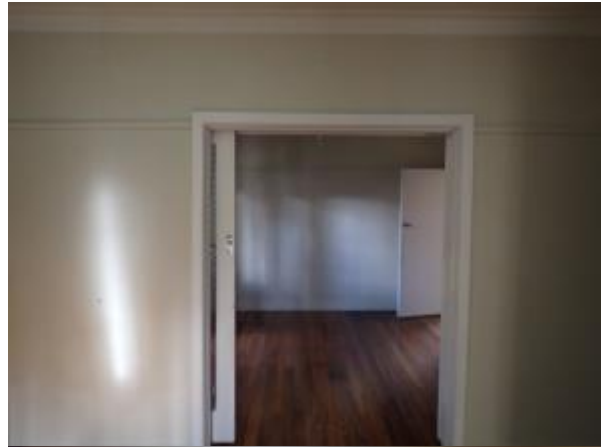
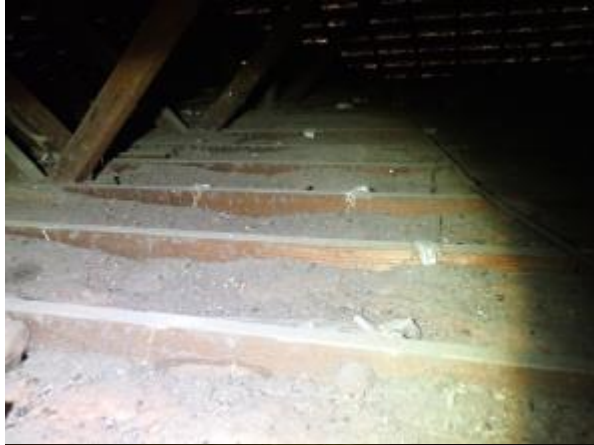
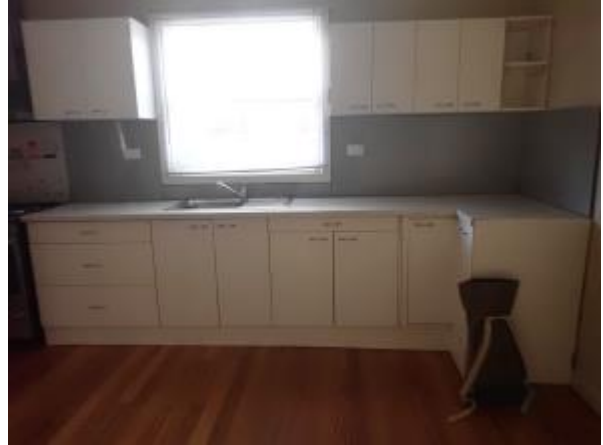
Under timber floor

Various defects

Major Defect

Re-stumping and replacement of various bearers and joists that are significantly bowed is required. This has resulted in significant movement of the floor level, window and door opening's and ceiling levels all requiring de-construction for adequate rectification. Replacement of the kitchen is also required as a result of significant movement out of level (removal is required in any case as flooring is significantly out of level and rectification will require replacement of sub-floor bearers and joists). It is highly recommended soils are dry prior to re-stumping.

Inspection of the sub-floor void is required to determine other defects prior to making the purchasing decision.

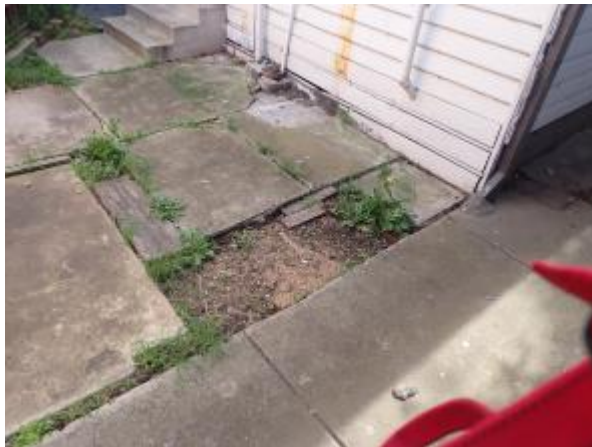
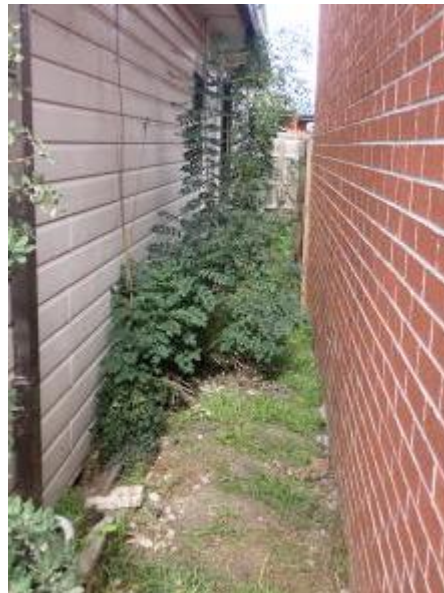
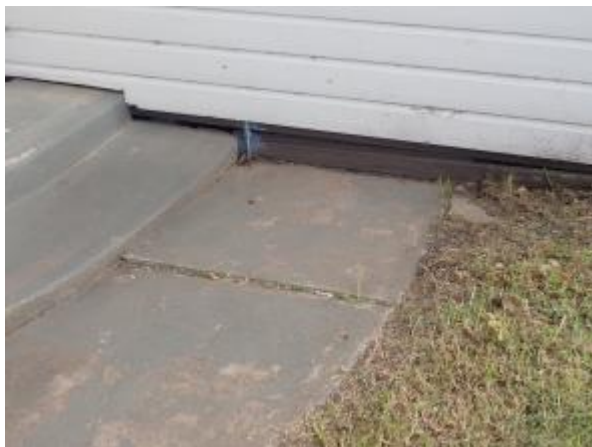
Surface water

Minor Defect

Poor site drainage occurs to various elevations where the land slopes and water flows toward the home. Sub-floor structures are significantly affected by poor drainage where structural movement defects to internal and external area's of the home may occur as a result. These defects commonly include cracking to internal linings, separation of architraves, binding doors, movement of floors out of level.

In this case, Major structural defects have occurred where re-stumping is required and due to the extent of curvature of various bearers and joists replacement of these is also recommended to prevent further defects in time. Movement of the internal and external walls have also occurred requiring squaring up of window and door opening's by a qualified carpenter.

In this case, it is recommended that the following occurs;

- 1. All perimeter concrete paving is removed (will be replaced later).*
- 2. Replacement of the storm water system and any repair to the sewer system undertaken by a licensed plumber.*
- 3. Installation of surface drains connected to the new storm water system.*
- 4. Concrete pavement installed with fall toward newly installed drains.*

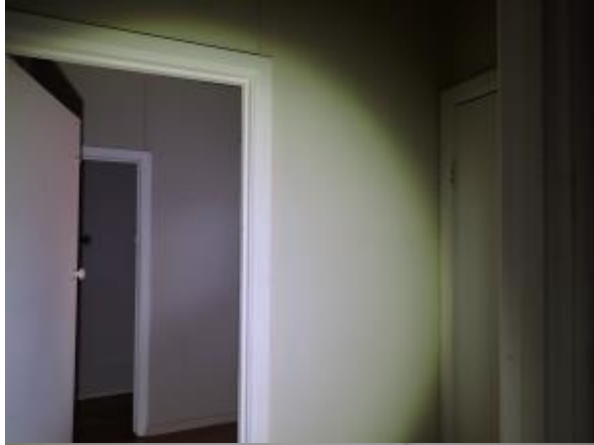
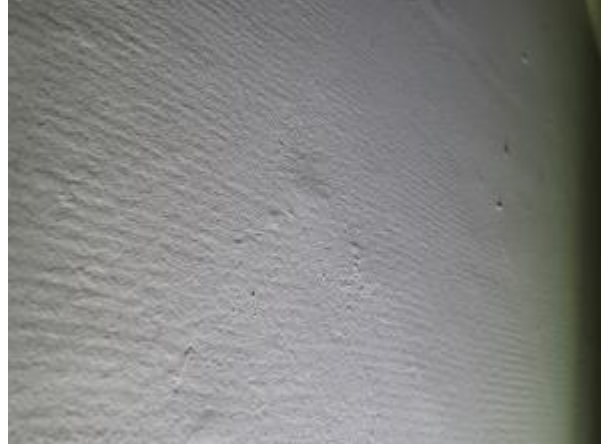
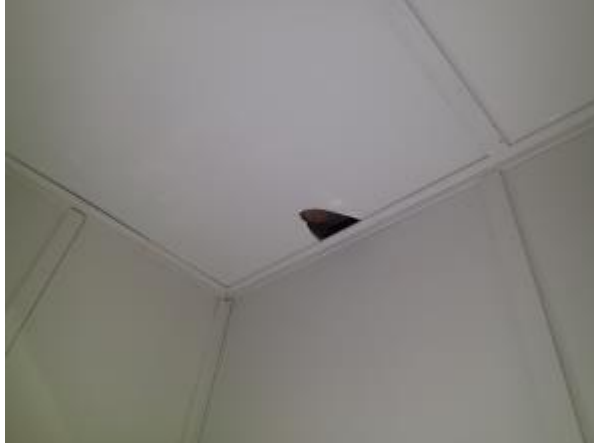
Hazardous materials Likely asbestos use to internal and external area's Safety Hazard Type: F

It is highly recommended an asbestos audit be undertaken by a suitably qualified persons prior to making a purchasing decision. Likely asbestos materials has been recorded to internal walls and ceiling linings of the toilet laundry and rear exit passageway. It is also likely asbestos as been used to external eaves lining's. Asbestos may be found to other areas within internal, subfloor roof void or external site areas. It is important to note that this not an asbestos audit.
